KELLETT
Aircraft
CORPORATION

DOWNWASH TESTS OF THE DUAL TANDEM
DUCTED PROPELLER VTOL RESEARCH
AIRCRAFT CONFIGURATIONS TO EVALUATE
ENGINE INLETS, PROTECTION DEVICES
AND STUDY AERODYNAMIC INTERFERENCE

DATE 11/1/65 REPORT NO. 179T80-12

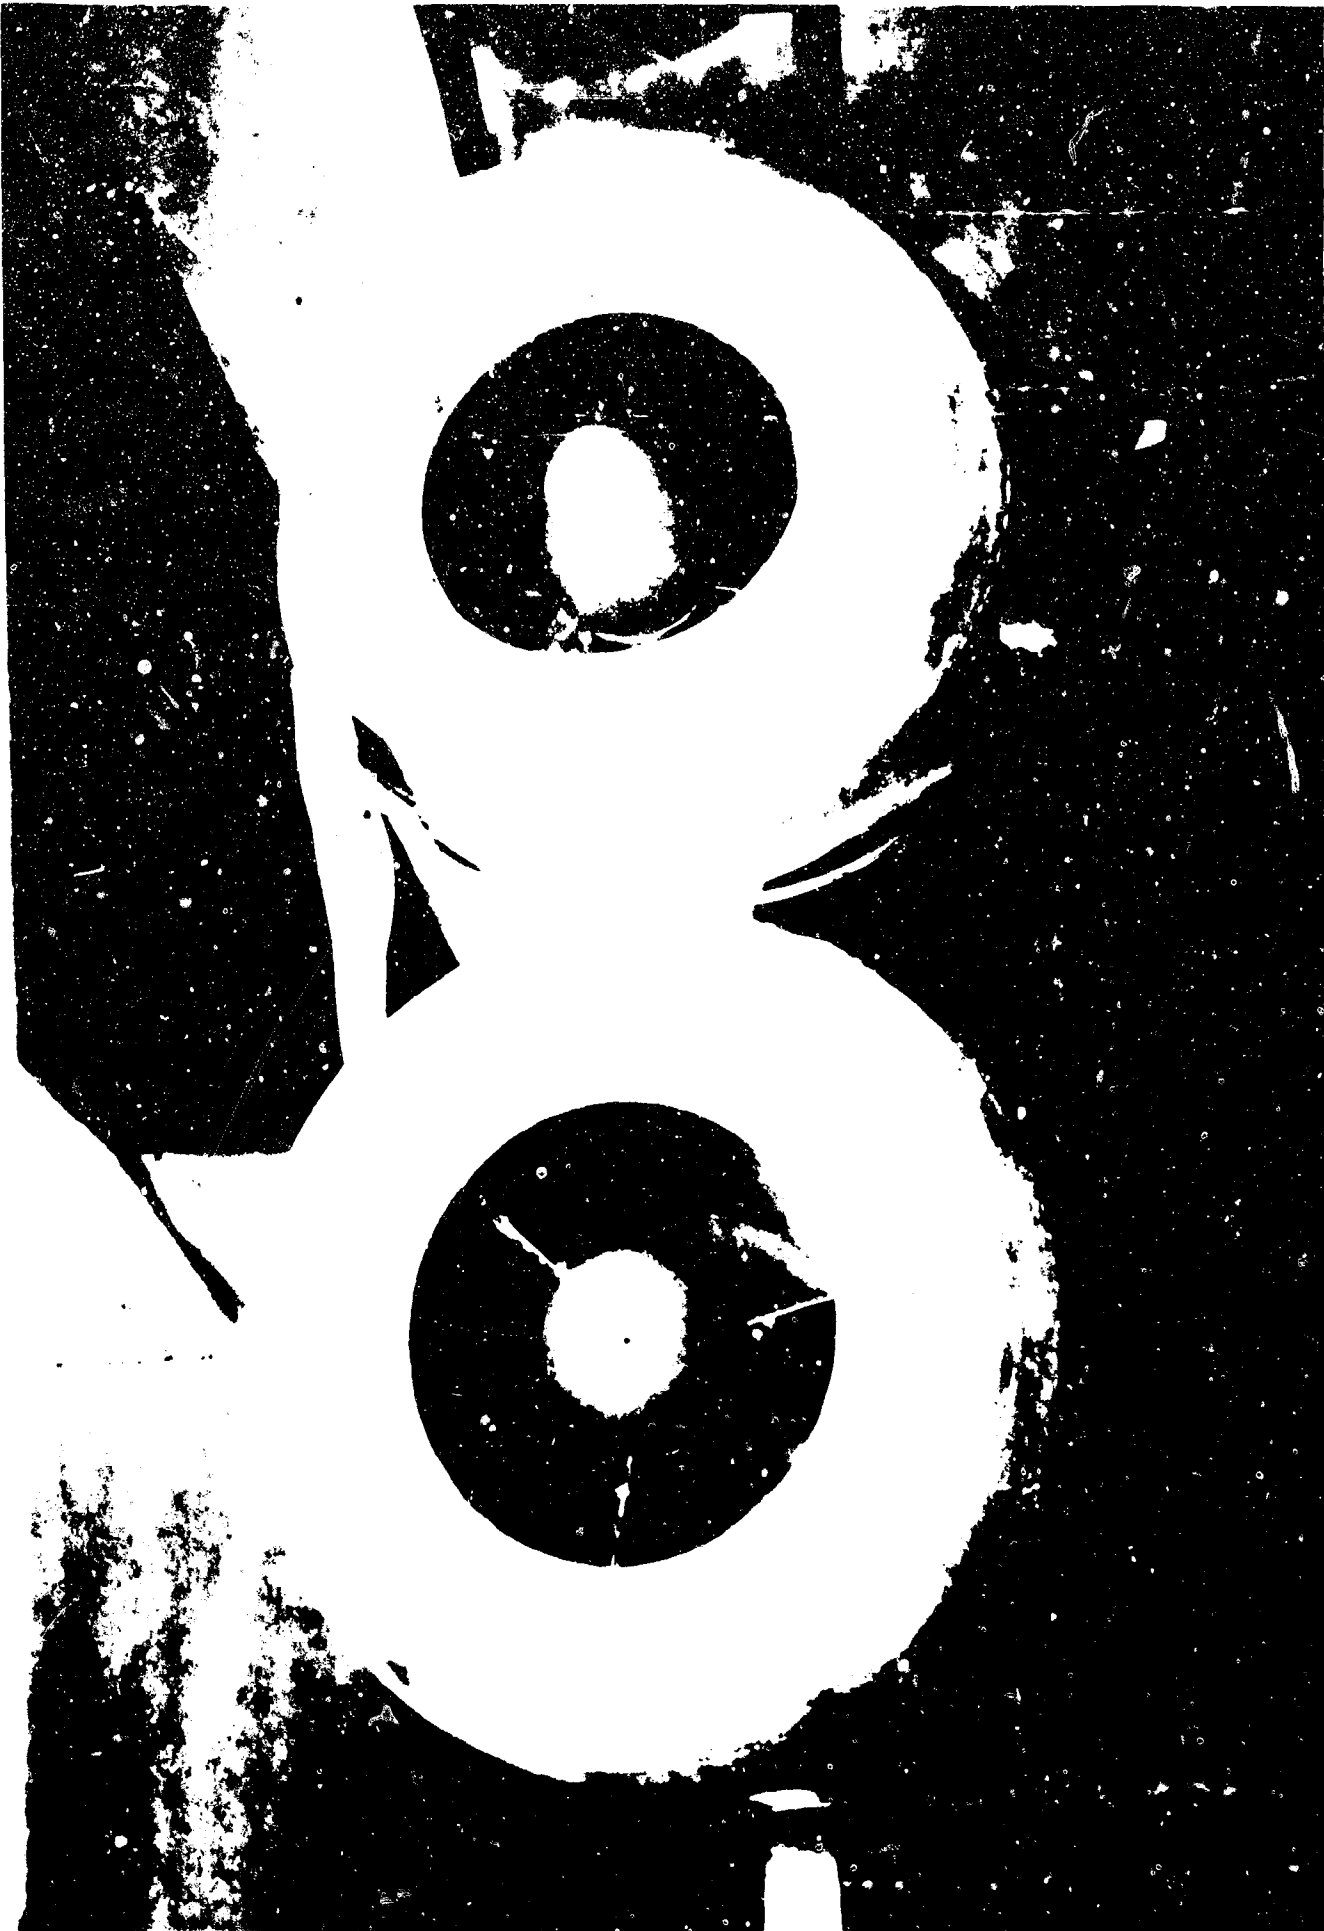
FIGURE 3: SIMULATED ENGINE INSTALLATION

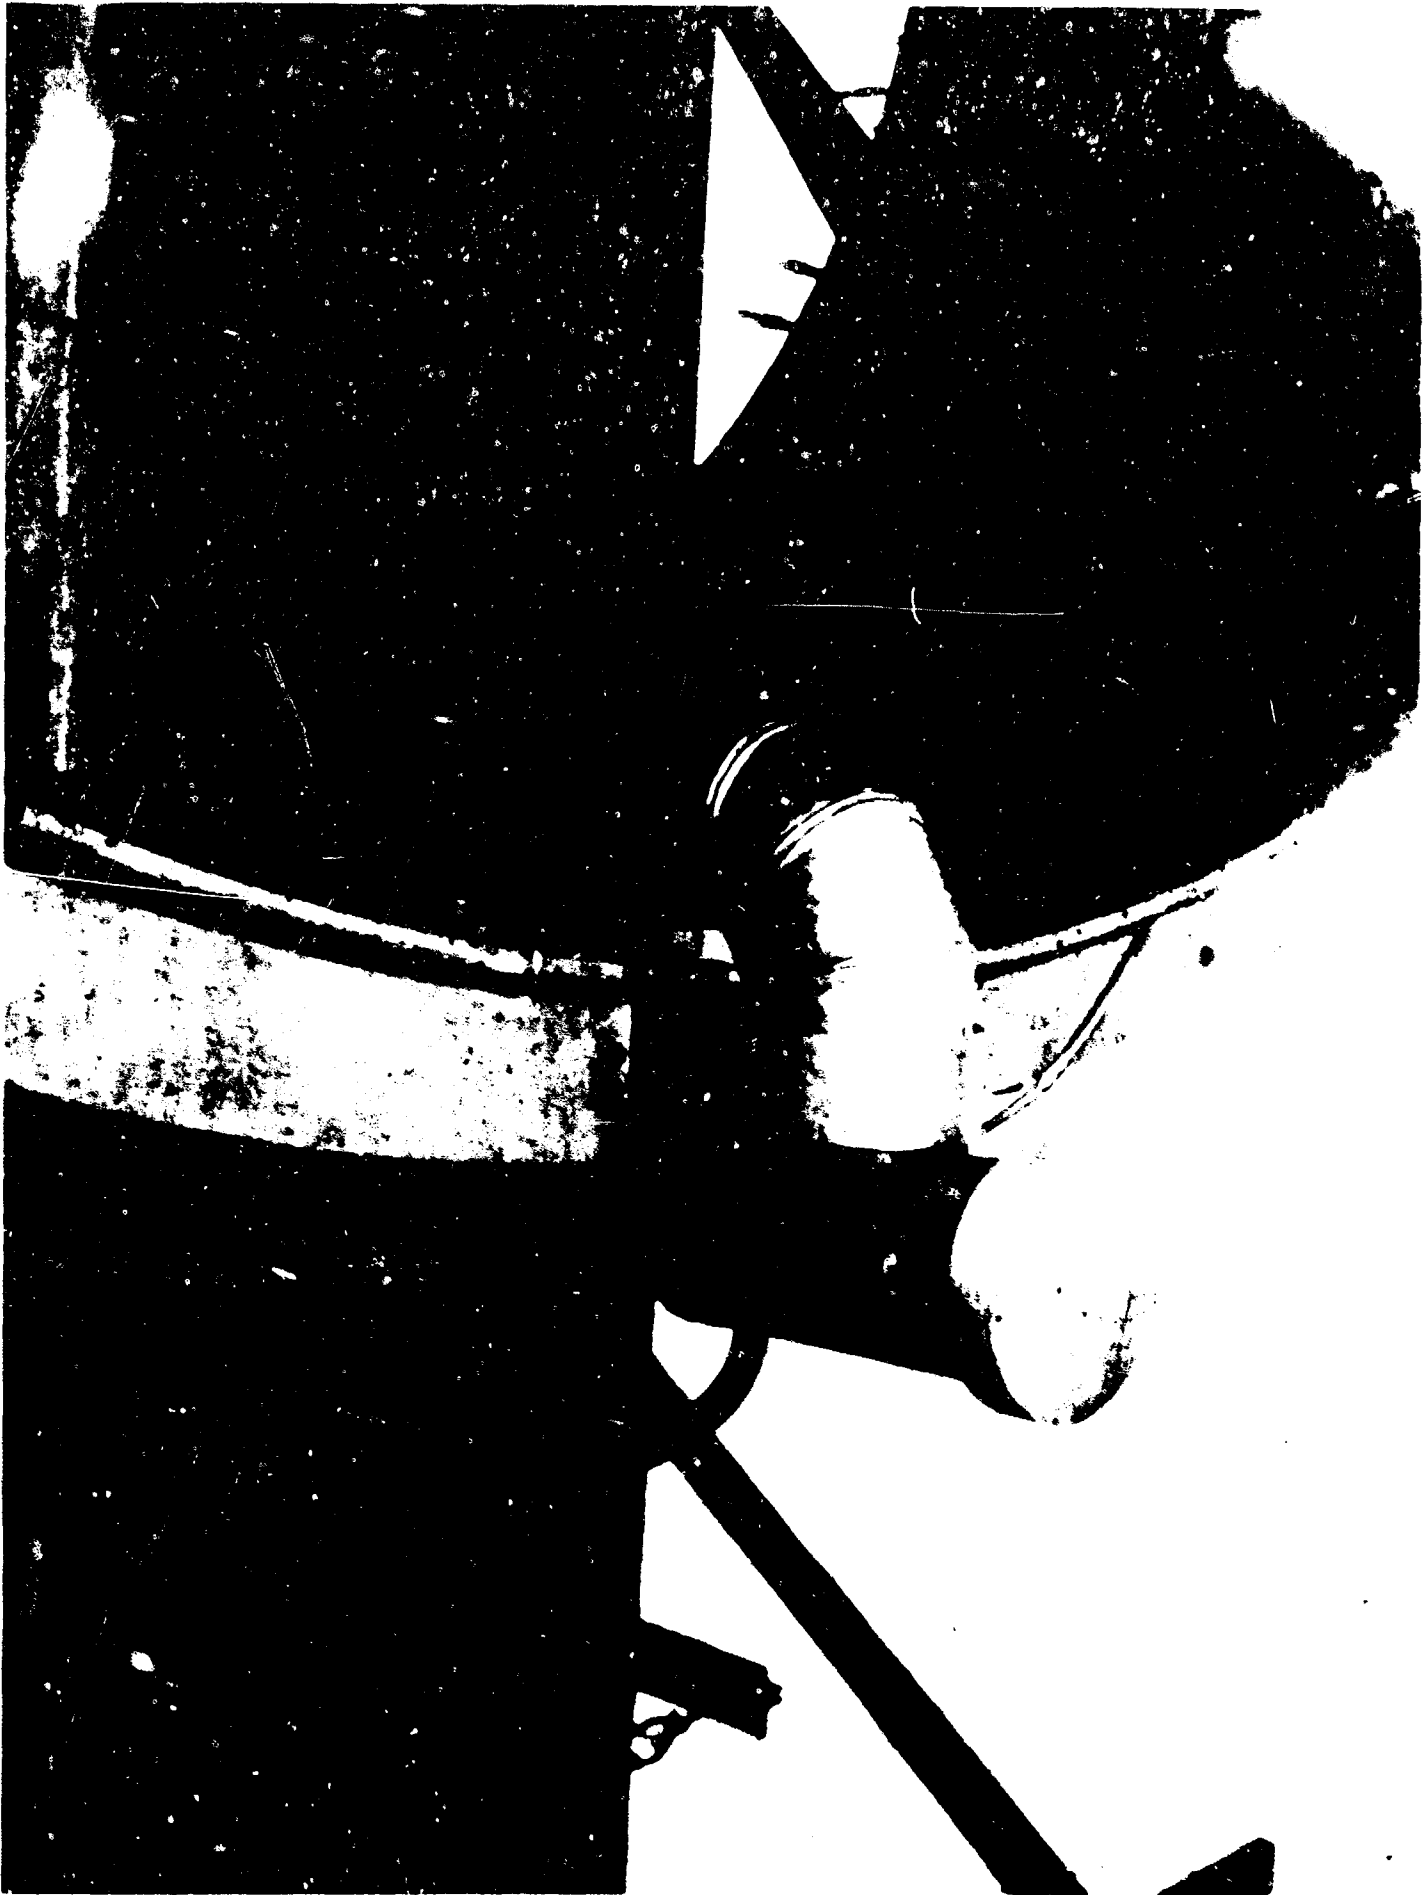
FIGURE 6: PROPELLER DUCT PARTICLE TRAP

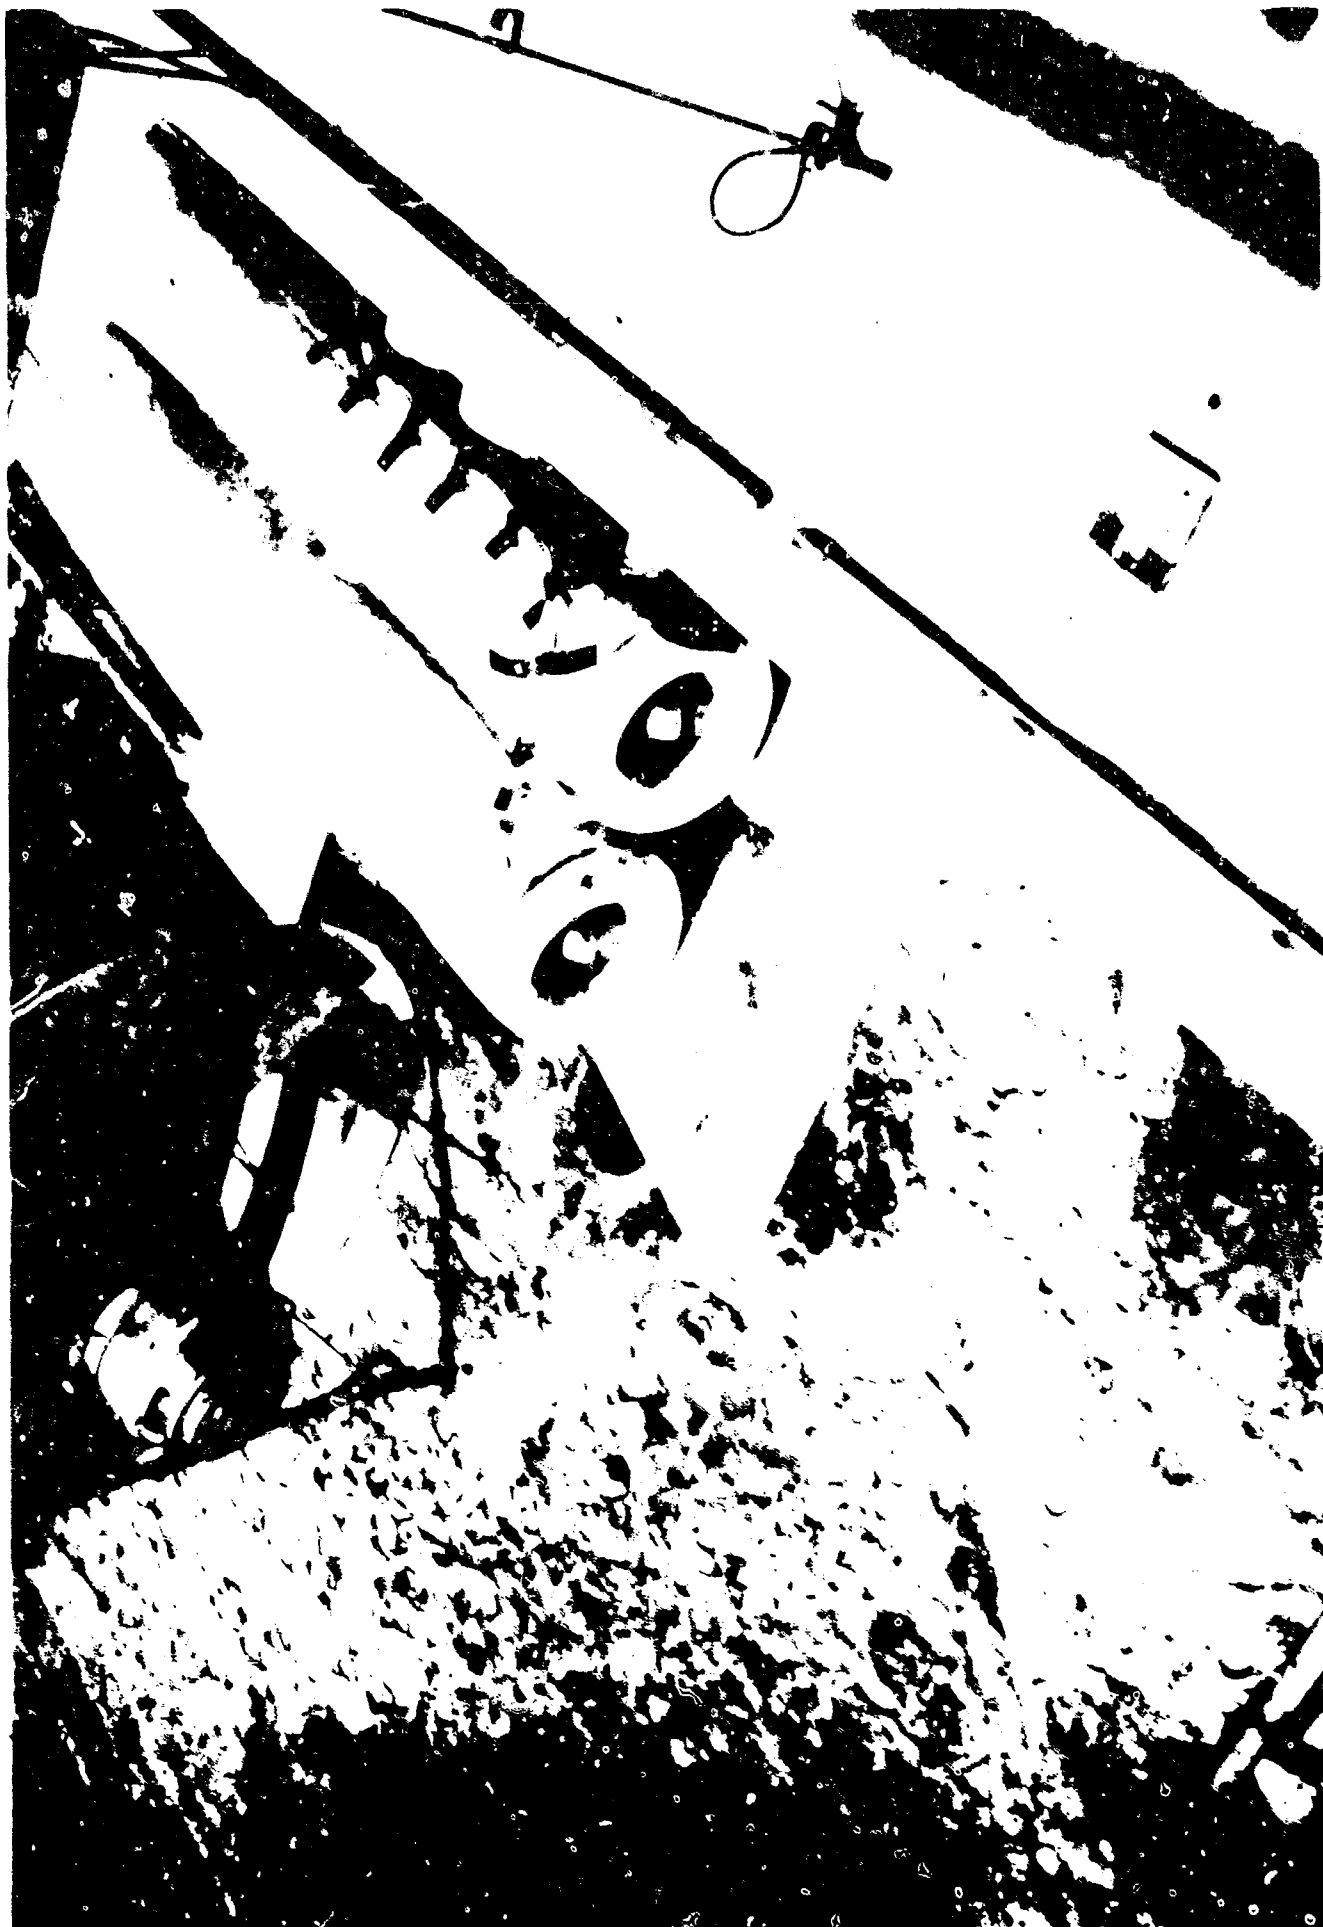
FIGURE 9: PHOTOGRAPH OF SHORT CHORD DEFLECTOR

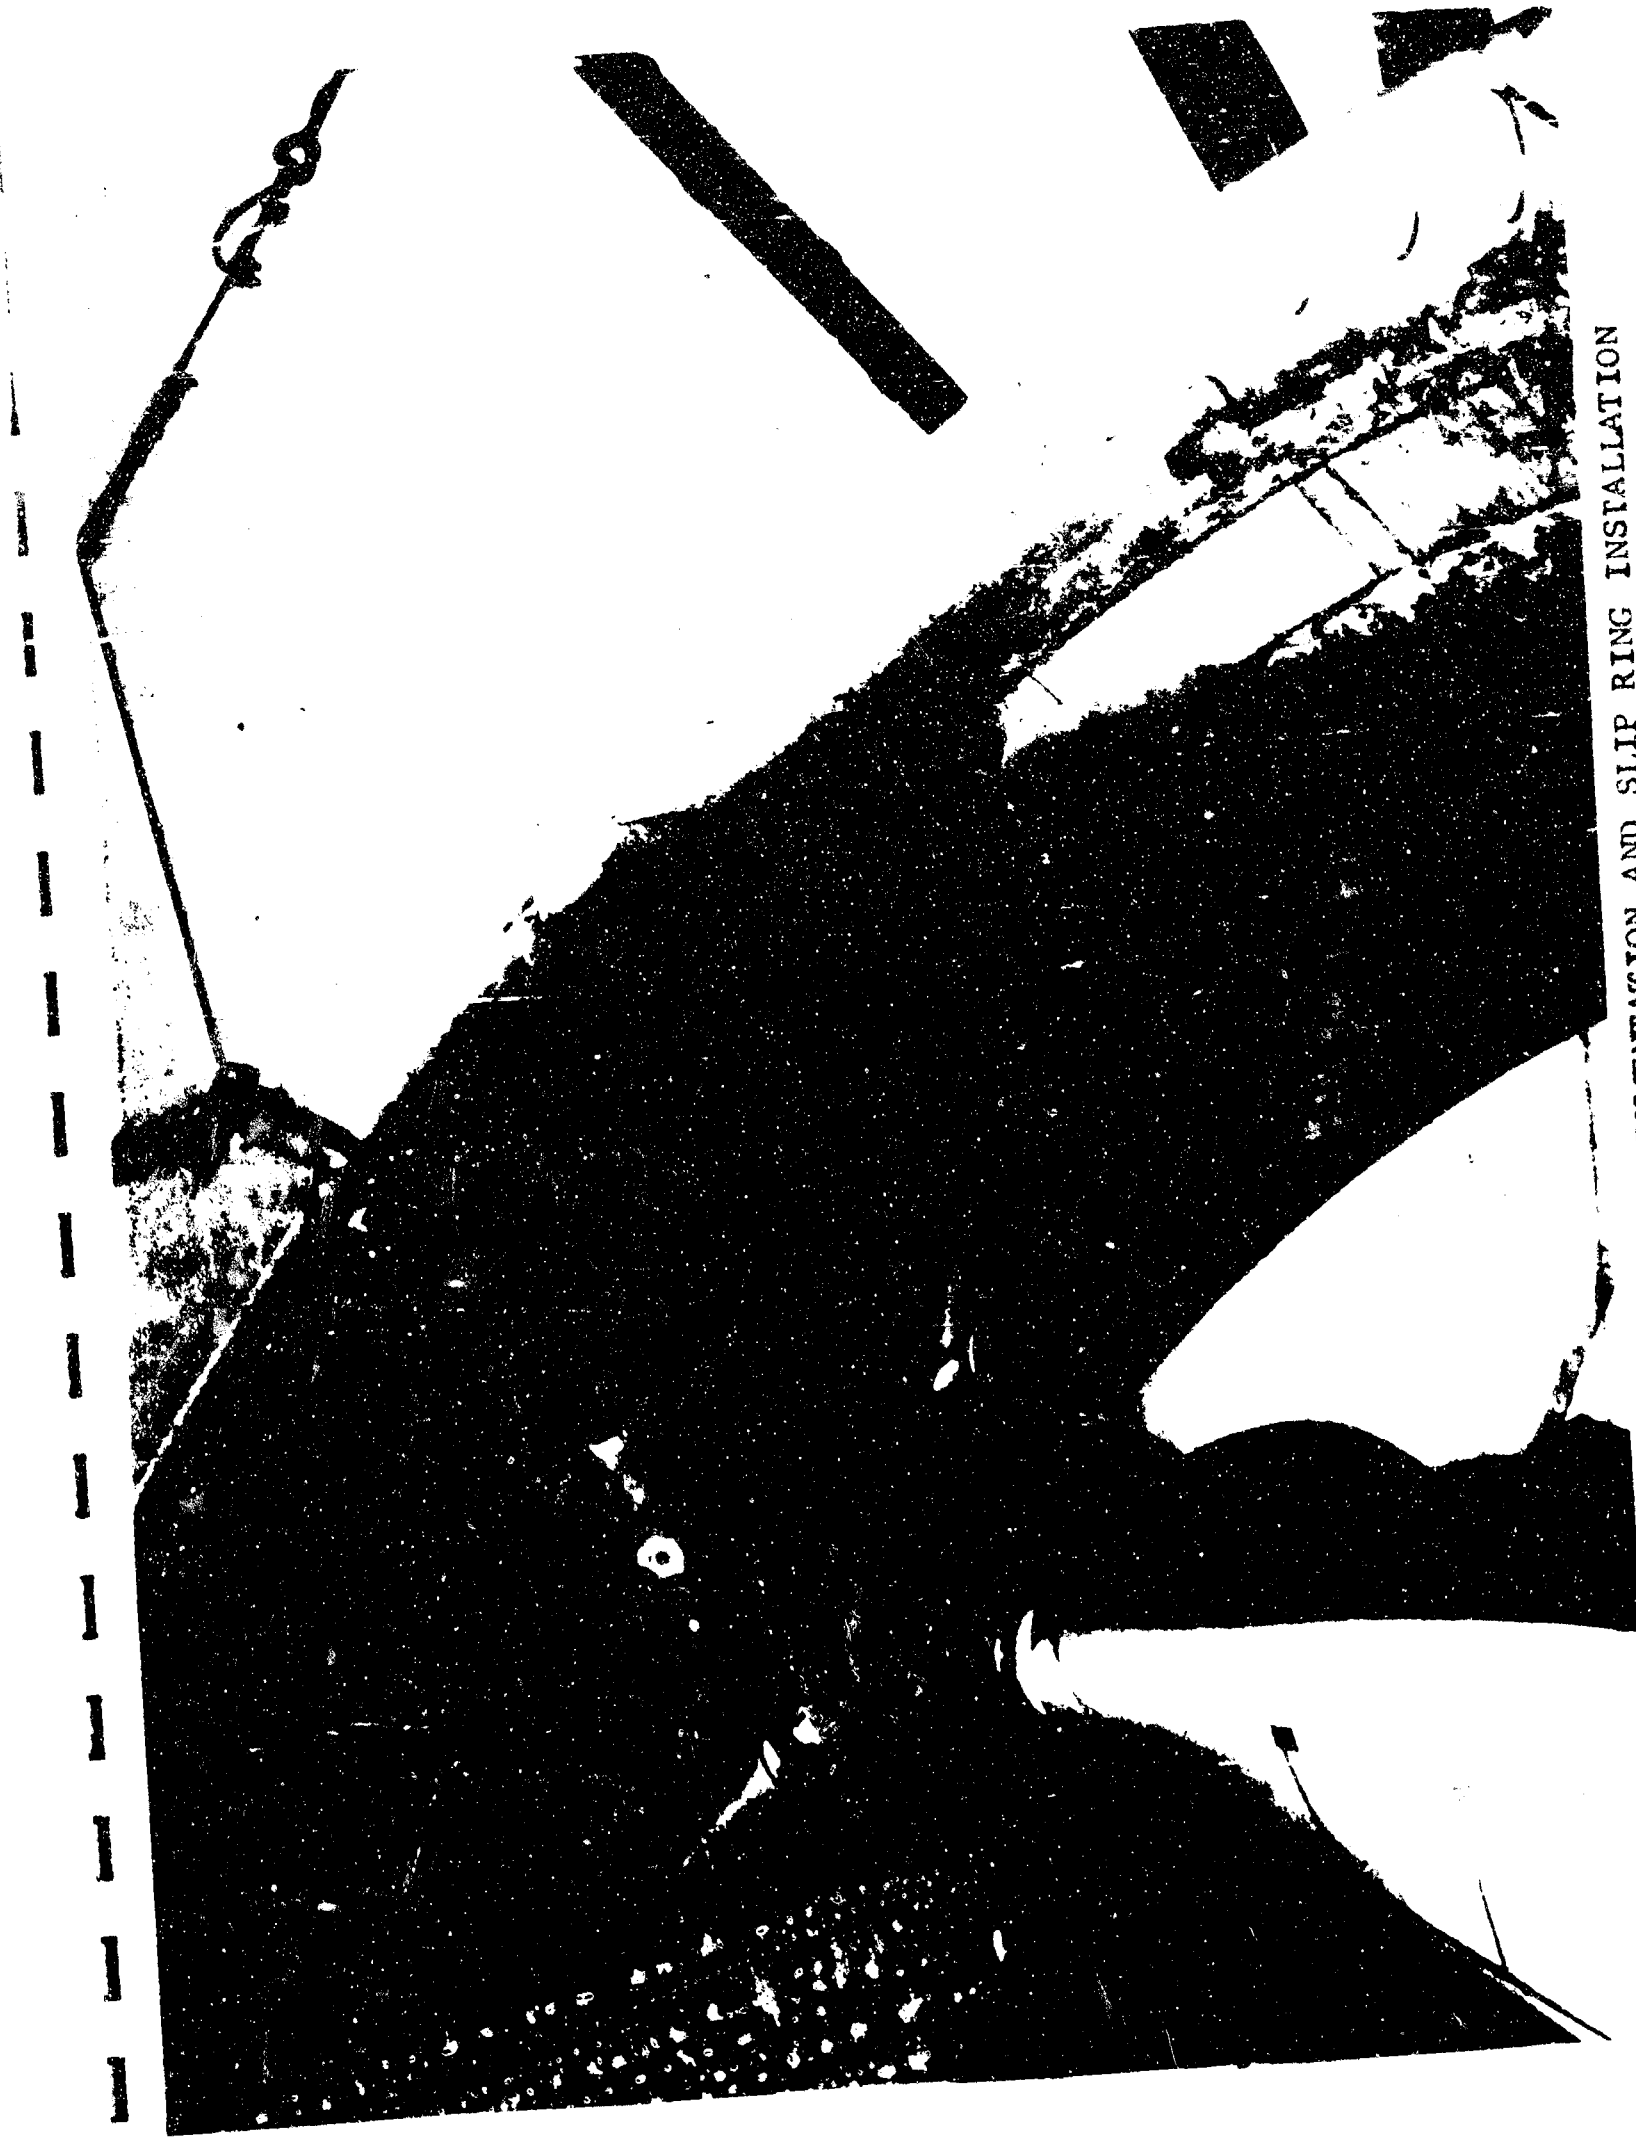
FIGURE 22: PROPELLER INSTRUMENTATION AND SLIP RING INSTALLATION

The program conducted by Kellett Aircraft Corporation described here was aimed at determining the low frequency components of the thrust as caused by the presence of two adjacent ducts in configurations similar to the X-22 aircraft. In addition, tests were conducted simultaneously by Hamilton Standard Division of UAC to measure the higher frequency components of stress in the blades. See Figure 22 for a photograph of the slip ring and strain gage installations. Strain
